CRSA

# FISHER MANSION HISTORIC STRUCTURE REPORT

FEBRUARY 05, 2010

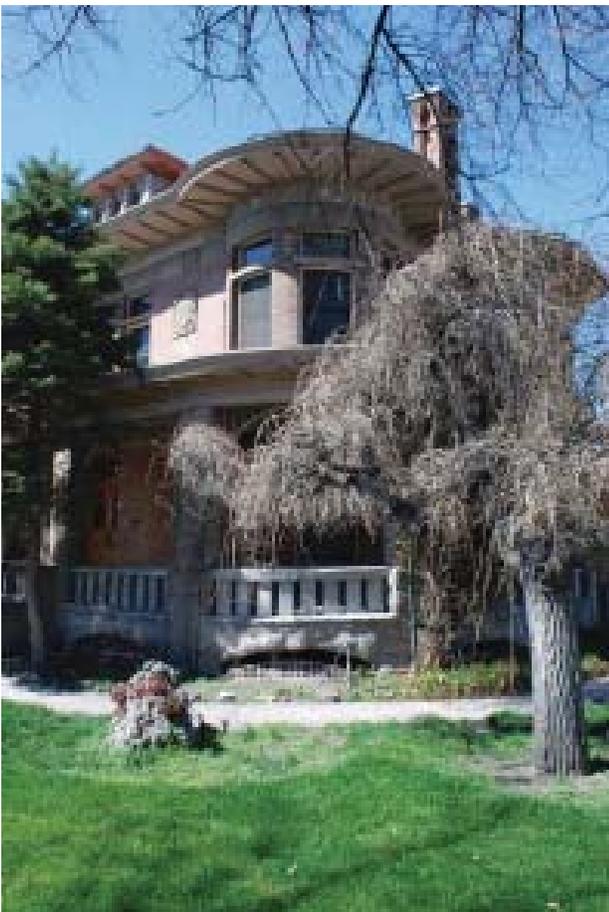
Southeast corner of the mansion; view of reconstructed porch railing and porch support arches.

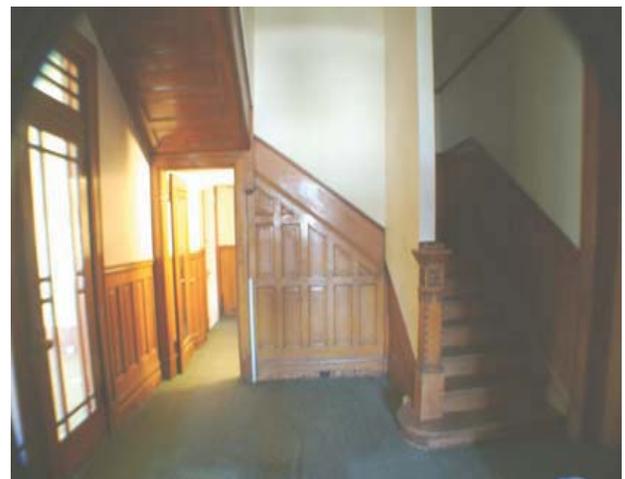
The grand staircase was enclosed for fire code reasons when the mansion was a group home

Completely remove the walls that enclose the grand staircase. Replace with a historically appropriate handrail that meets current code requirements for height. Some of the balusters from the original handrail are being stored in the carriage house and can be used as

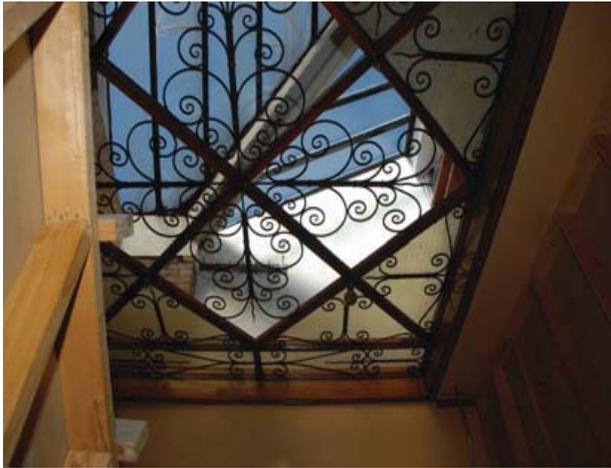
The decorative skylight above the main staircase had been covered over but remains mostly intact

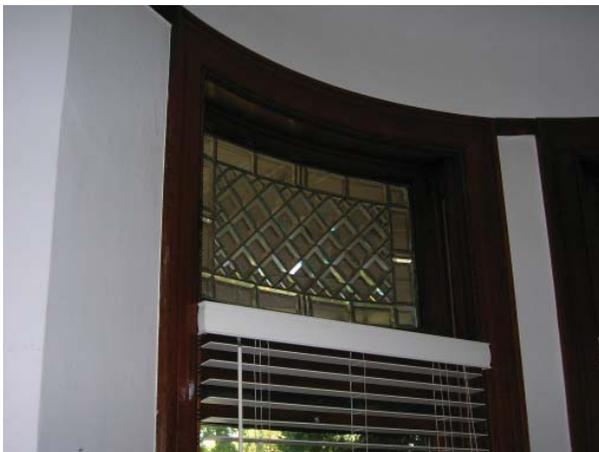
Curved, decorative leaded glass was used in the transoms of all the bay windows; it only remains in the southeast bay

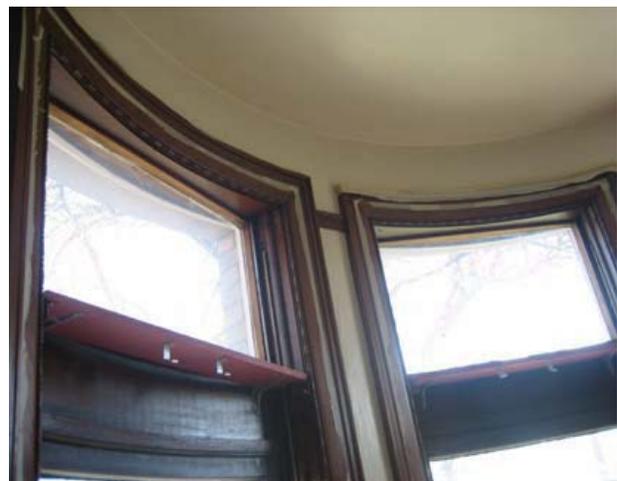
View of the southeast bay transoms on the second level; the original curved glass has been replaced with a flat glass

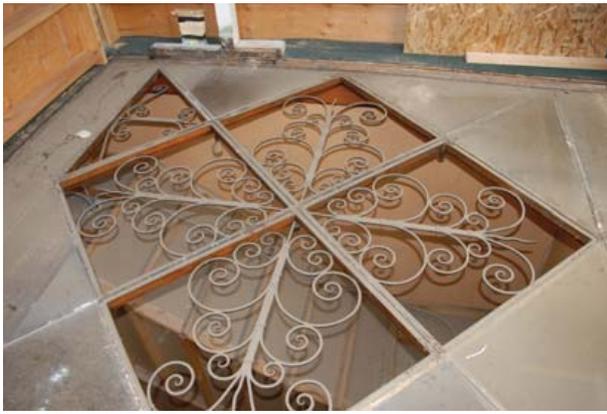
The decorative skylight frame shows signs of serious corrosion due to sustained water damage. There are numerous panels missing or broken in the frame.

View of the decorative skylight panel from above; some of the panels have been damaged or are missing

improvements. Check windows for weatherproofing and make necessary repairs. Install short railing around skylight and repair and install missing or damaged panels to decorative skylight frame. Check sloped skylight for weathertightness and make necessary repairs.

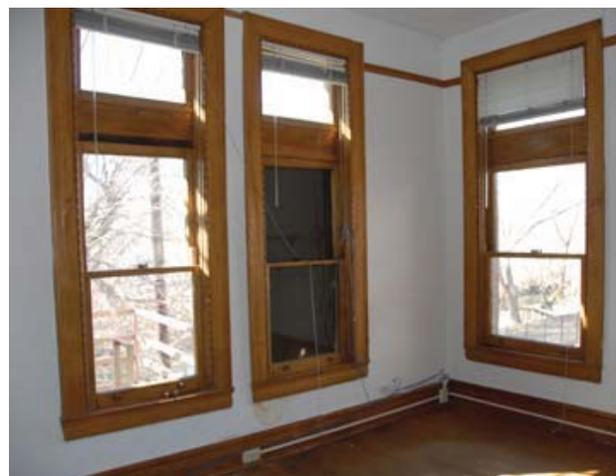
A view of the northwest bedroom; external conduit has been applied on top of the baseboard

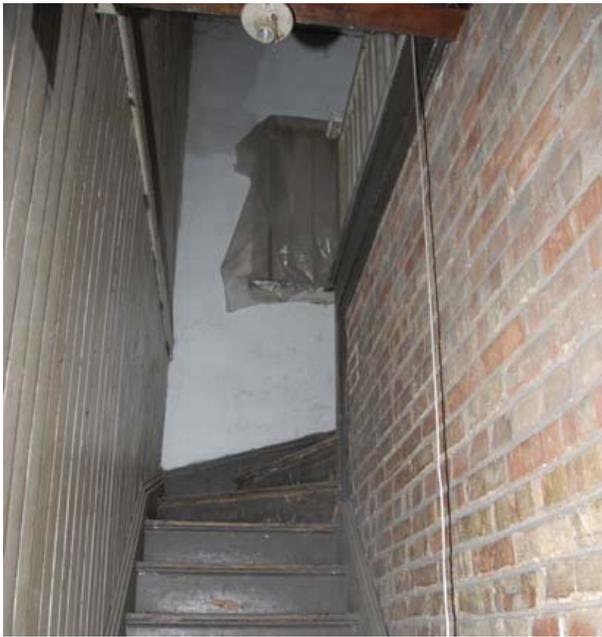
The stairway in the carriage house is in poor condition, with some broken treads

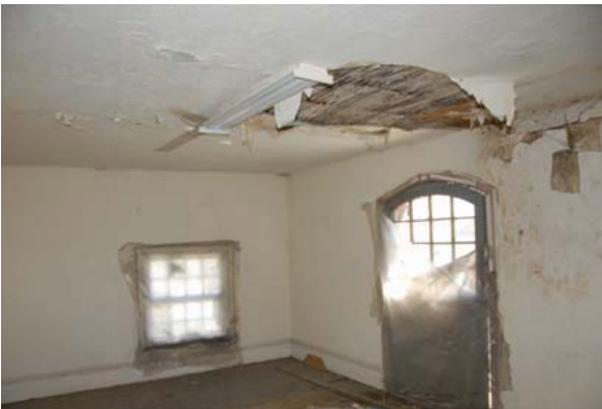
The southeast room on the second level of the carriage house ; moisture has caused plaster damage to the walls and ceiling
